ANALYSIS AND TEST OF REPAIR CONCEPTS FOR A CARBON-ROD REINFORCED LAMINATE

Donald J. Baker*
 Vehicle Technology Directorate - ARL
 NASA Langley Research Center
 Hampton, Virginia 23681 - 2199
 and
 Carl Q. Rousseau**
 Bell Helicopter Textron
 Ft. Worth, TX 76101

Abstract

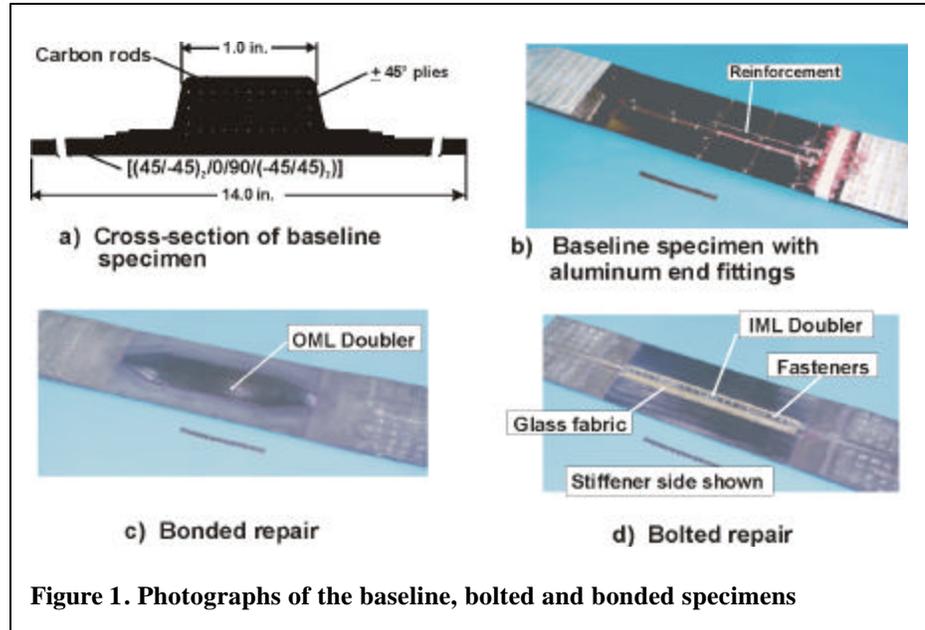
Figure 1. Photographs of the baseline, bolted and bonded specimens

cured using the appropriate Bell Helicopter process-specification. The baseline test specimen cross section is shown in figure 1a. The skin is a [(45/-45)₂/0/90/(-45/45)₂] laminate of IM7/8552 carbon-epoxy tape material. The 1.0-inch wide carbon-rod reinforcement (rodpack) is formed from four layers of IM7 carbon-epoxy rods (Neptco, 0.067-inch diameter) embedded in a syntactic adhesive (Hysol HC9872) and sandwiched between layers of [\pm 45] IM7/8552 carbon-epoxy tape which extends over the skin. Each end of the specimen is reinforced with a [\pm 45] tab for attaching the aluminum load introduction fittings. This specimen will be identified as the baseline specimen for the remainder of this paper. A photograph of the baseline specimen

with the aluminum load introduction fittings is shown in figure 1b. The test section is 36-inches long and the overall specimen length is 70 inches not including the aluminum end fittings. The aluminum fittings are bolted to the loading tabs. The bonded repair and bolted repair specimens are shown in figures 1c and 1d, respectively.

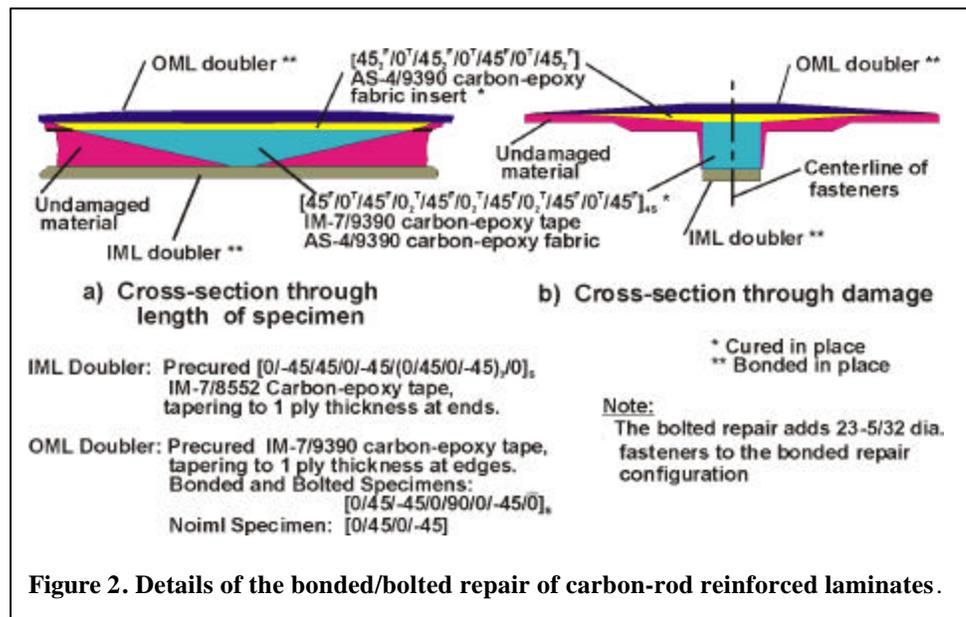
Figure 2. Details of the bonded/bolted repair of carbon-rod reinforced laminates.

The wet-lay-up scarfed inserts that replace the rodpacks and the skin plugs were fabricated in-situ from dry carbon plain- and uni-weave fabric with EA9390 resin. Details of the repair inserts are shown in figure 2.

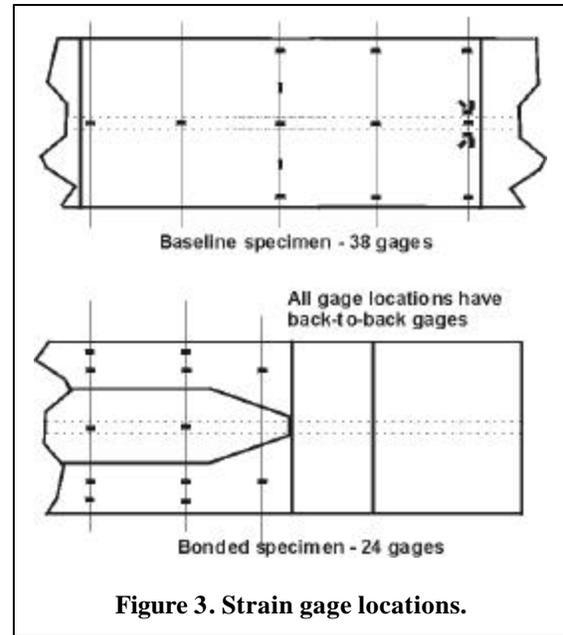
Figure 3. Strain gage locations.

All specimens were instrumented with strain gages. The gage layout for the baseline specimen and the bonded repair specimen are shown in figure 3. The baseline specimen has 38 strain gages and the repaired specimens had 24 or 25 strain gages. The specimen elongation was measured with a linear variable displacement transducer (LVDT) measuring the change in distance between the loading pins.

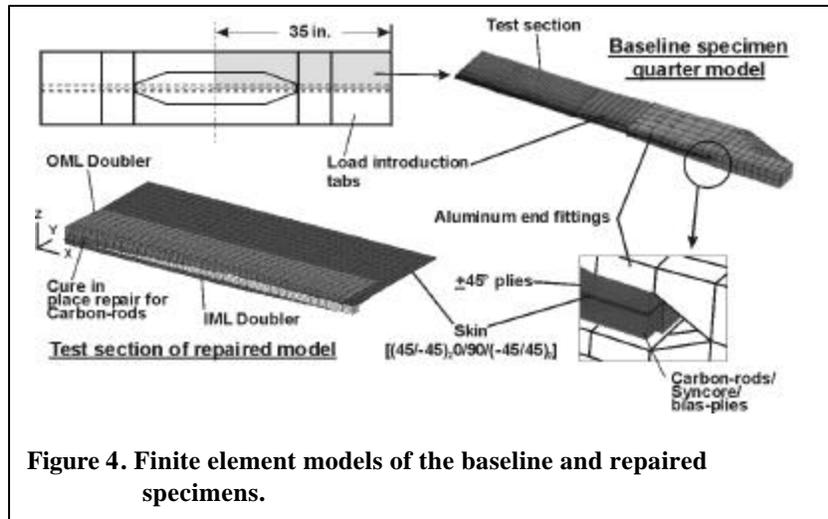
Figure 4. Finite element models of the baseline and repaired specimens.

A linear analysis of the specimen response was performed using MSC/NASTRAN (ref 11), Version 70.5, and 8-node brick or tetrahedron elements. Since the specimen is symmetric in two planes only one-fourth of the specimen was modeled. The finite element models of the baseline specimen and the bonded specimen are shown in figure 4. The models for the repaired specimens do not include the adhesive used in attaching the doublers. A perfect bond is assumed between the cured in-place inserts and the basic material. All the models include the composite load introduction tabs and the aluminum load introduction fittings. The aluminum fittings are attached to the loading tabs with rigid links. The predicted displacement results for the baseline specimen; the bonded specimen; and the no-IML specimen corresponding to an applied load of 100 kips are shown in figure 5a. The effect of the carbon-rods in shifting the specimen neutral axis is demonstrated in the figure with the out-of-plane bending. All specimens deflect in the +z direction. The baseline specimen has the largest out-of-plane displacement with the no-IML specimen the next largest. The bolted specimen has very little out-of-plane deflection at the reinforcement but the skin deflects in the -z direction.

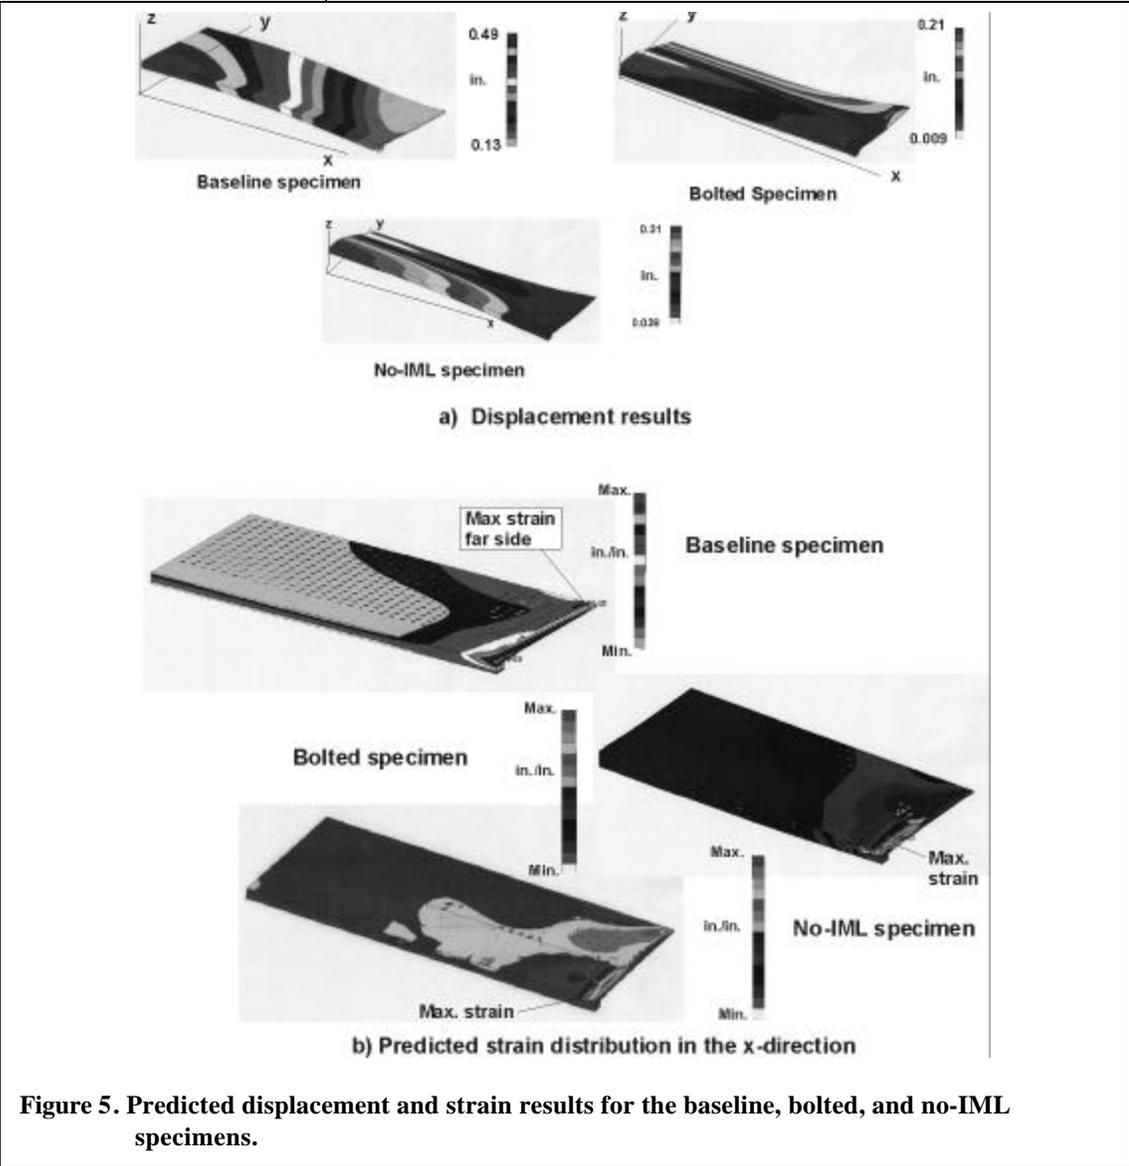
Figure 5. Predicted displacement and strain results for the baseline, bolted, and no-IML specimens.

The predicted x-direction strain (ϵ_x) for the baseline specimen, the bolted specimen, and the no-IML specimen are shown in figure 5b. The maximum ϵ_x strain for the baseline specimen is at the edge of the skin adjacent to the reinforcing tab, very likely the result of the stiffness mismatch between the laminate and the load introduction tab. The maximum strain in the repaired specimens is in the basic specimen at the termination of the repaired area.

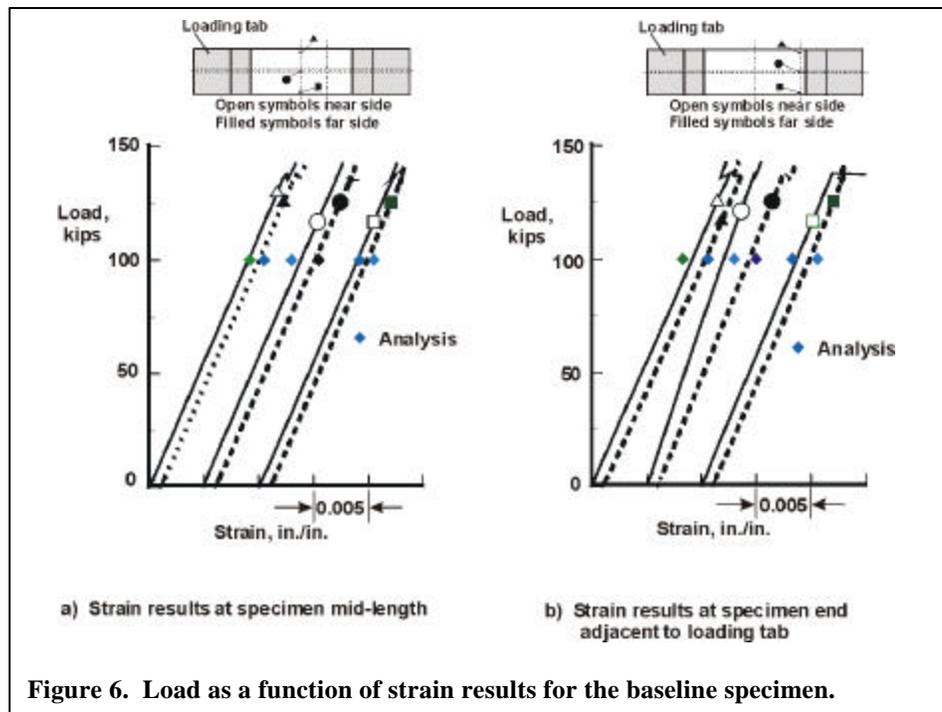
Figure 6. Load as a function of strain results for the baseline specimen.

shown in figure 6a. The specimen mid-length strain on the centerline of the stiffener appears linear to failure while the strain at one of the edges (box symbol) of the specimen drops at the load drop but the opposite edge strain (triangle symbol) increases at the load change. The results from strain gages located near the reinforced end are shown in figure 6b. The effect of the rod reinforcement on the section bending can be seen in the difference in the strain of the back-to-back gages (filled and open circles) on the centerline reinforcement. This type of response can be expected when looking at the predicted deflected shape in figure 5a. The strain in the reinforcement also increases when the load drops. The strain gages on the skin do not indicate any large

bending. The strain in the gage with the open box symbol (figure 6b) increases off scale when the load drops which is a good indication that the failure initiated in the area of the gage. To support this a photograph of the failed baseline specimen is shown in figure 7, which

The computed strains are shown in figure 6 as diamond symbols. The computed strains are within 11% of the experimental strains and compare well with the experimental strains.

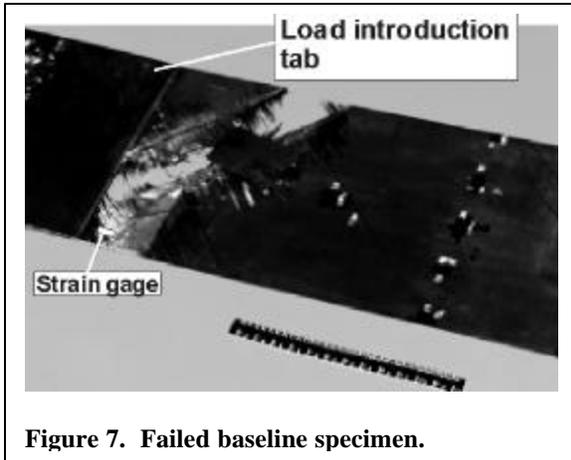
Figure 7. Failed baseline specimen.

indicates that the specimen failed at the location of the gage. The elongation of the baseline specimen measured between the loading pins is shown in figure 8. The slope of the experimental curve between 50 kips and 125 kips is 193.5 kips/in. Also shown in the figure is the computed elongation, which has a slope of the 267.4 kips/in. There are many variables that can contribute to the difference between the experimental and computed elongation, such as loading pin bending, attach fastener bending, hole elongation, etc. The stiffness of the baseline specimen is 72 percent of the computed stiffness. The lag in the response up to 50 kips shown in figure 8 is a result of the slack in the test machine.

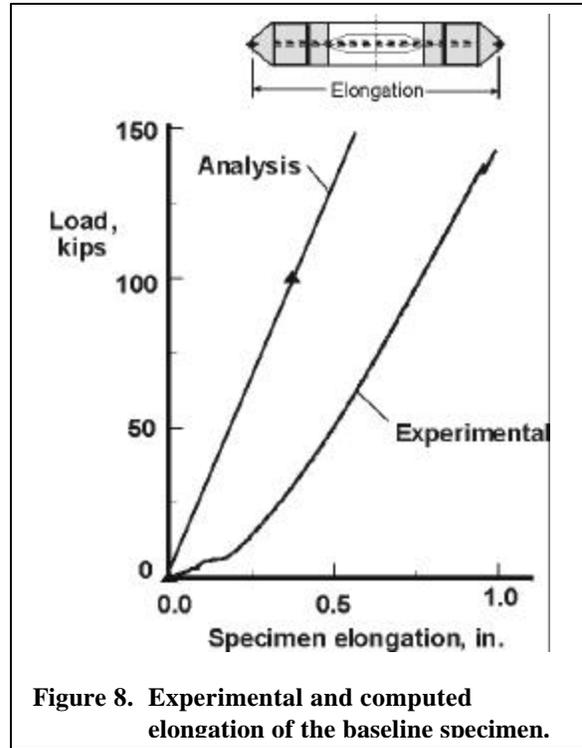
Figure 8. Experimental and computed elongation of the baseline specimen.

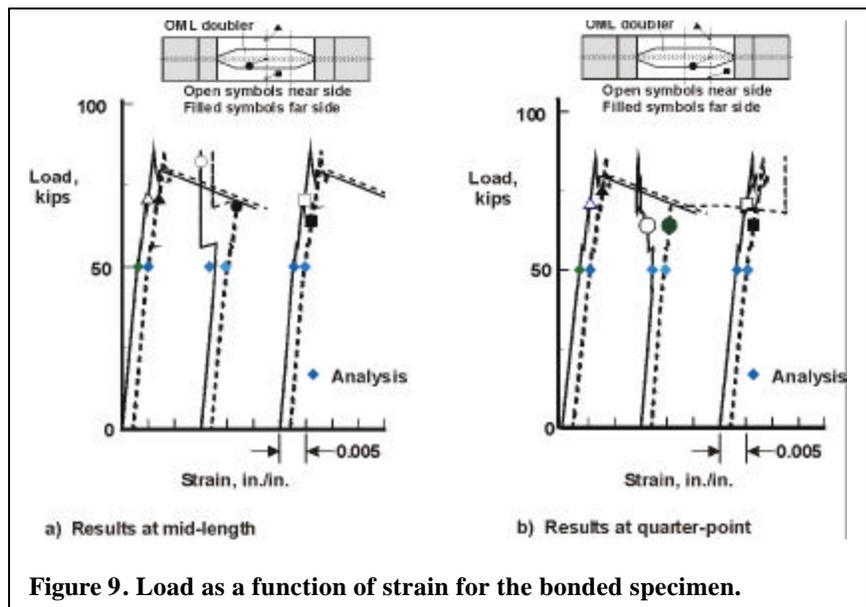
Figure 9. Load as a function of strain for the bonded specimen.

gages along the centerline of the specimen. At 57 kips the OML doubler delaminated between the first and second ply as shown by the dropping of strain to zero at the open circle locations in figure 9a and to a very small strain at the quarter point as shown by the open circle locations in figure 9b. At 70 kips a similar failure occurred on the IML doubler where the strain (filled circle in fig.6a) went to zero at the mid-length of the specimen and the strain in the IML doubler at the quarter point went off scale. The specimen continued to carry

The computed strains for a load of 50 kips are shown in figure 9 as the diamond symbols. Good agreement is shown between the computed and experimental strains except for the strain in the OML doubler at the specimen mid-length.

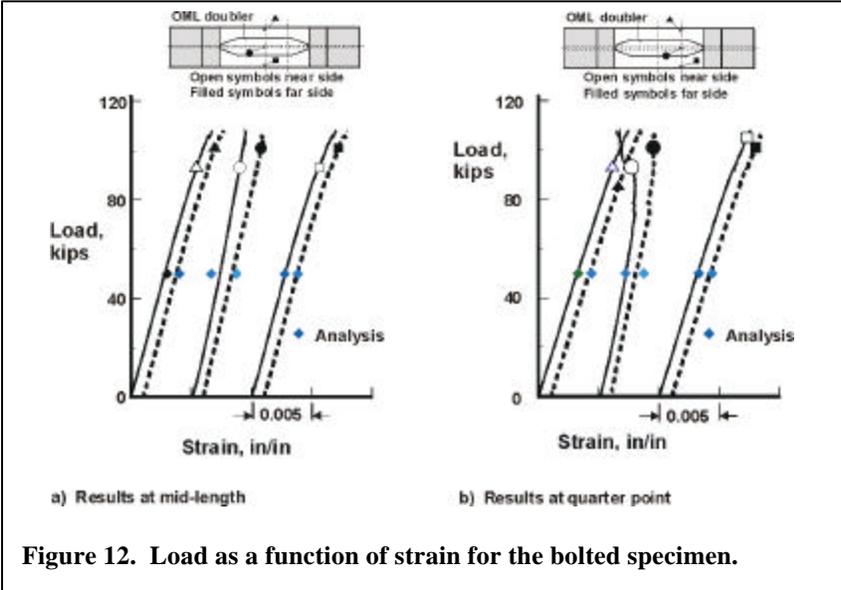
Figure 12. Load as a function of strain for the bolted specimen.

at the quarter-point location starts to drop at approximately 70 kip load and continues to drop until failure. Strain in the IML doubler also starts to drop at approximately 70 kips but at a lower rate than in the OML doubler. Failure started in the specimen with the bolts pulling through the tapered end of the OML doubler as the IML doubler was failing in the tapered end. The strength retention of the bolted specimen is 76 percent of the baseline specimen. Final failure was at the end of the machined taper for the repair as can be seen in figure 13. The elongation of the bolted specimen

The computed strains are shown in figure 12 as the diamond symbols. Good agreements are shown between the computed and experimental strains in the skin (triangles and squares) and are within 10 percent of the experimental strains. The computed strain in the OML doubler at the specimen mid-length is less than the experimental strain while there is a good agreement at the quarter-point. The analysis over predicts the strain in the IML doubler at both locations.

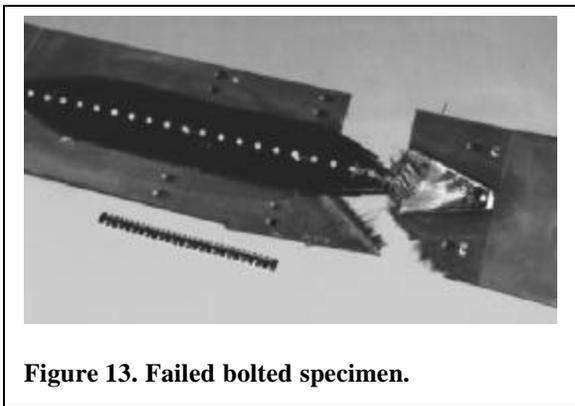
Figure 13. Failed bolted specimen.

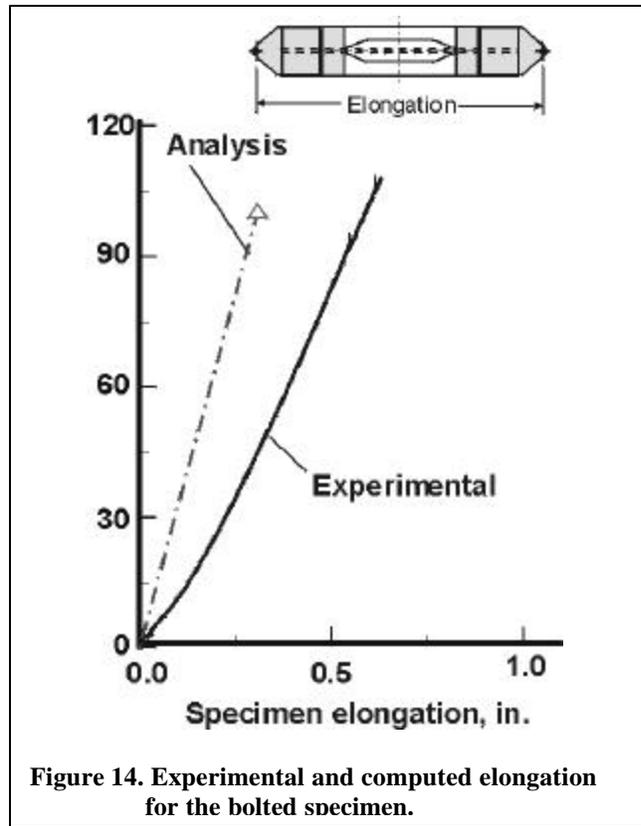
Figure 14. Experimental and computed elongation for the bolted specimen.

measured between the loading pins is shown in figure 14. The slope of the experimental curve between 50 kips and 100 kips is 199.7 kips/in. Also shown in the figure is the computed elongation, which has a slope of the 325.8 kips/in. The stiffness of the bolted specimen is 61 percent of the computed stiffness. The start of the doubler failures at 70 kips did not appear to effect the overall specimen stiffness.

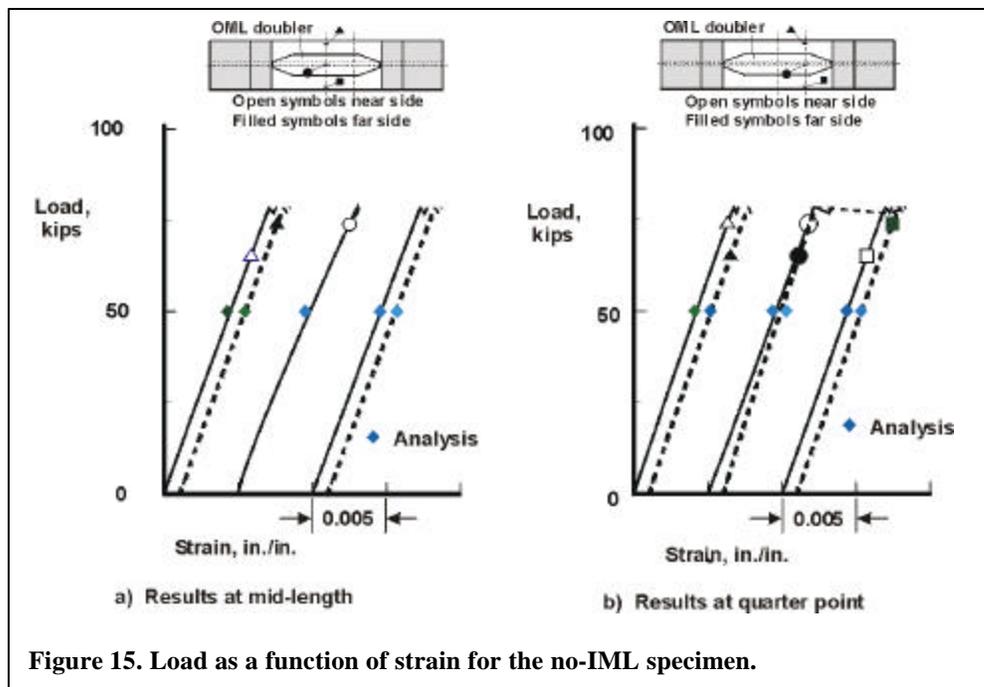
Figure 15. Load as a function of strain for the no-IML specimen.

figure 15. The strain in all gages increases monotonically until the load is near failure. The specimen failed at mid-length as shown in figure 16. The elongation of the no-IML specimen measured between the loading pins is shown in figure 17. The

The computed strains are shown in figure 15 as the diamond symbols. Good agreement is shown between the computed and experimental strains in the skin (triangles and squares) and are within 10 percent of the experimental strains.

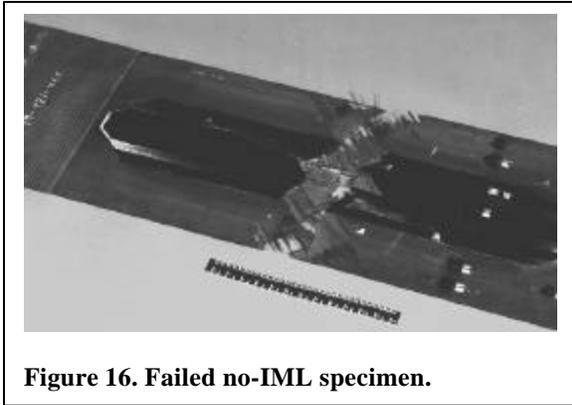
Figure 16. Failed no-IML specimen.

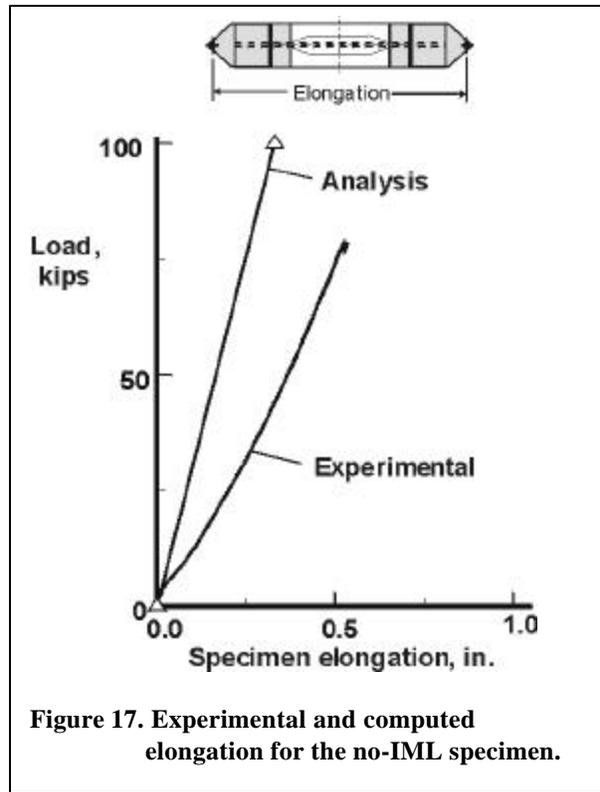
Figure 17. Experimental and computed elongation for the no-IML specimen.

slope of the experimental curve between 50 kips and 75 kips is 181.9 kips/in. Also shown in the figure is the computed elongation, which has a slope of the 237 kips/in. The stiffness of the no-IML specimen is 77 percent of the computed stiffness.

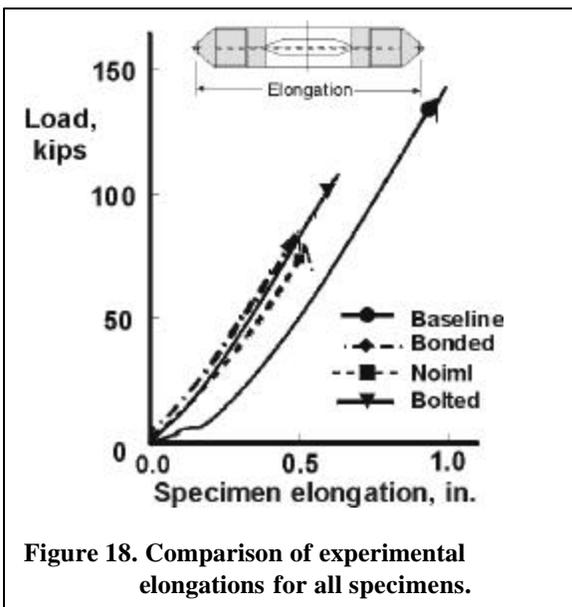
Figure 18. Comparison of experimental elongations for all specimens.

A comparison of the elongation of each repair concept as a function of the applied load is shown in figure 18. Since the slopes of the curves shown in figure 18 are very similar, these results suggest that the repair had little effect on the specimen axial stiffness and these repair techniques could be used in a stiffness critical application with minimal impact.
